## IsThisCarOK

A briefing before you meet the seller

# Know what to verify before you offer

2011 Subaru Forester AWD · Seattle, WA · 92,635 miles · Asking \$8,000 USD

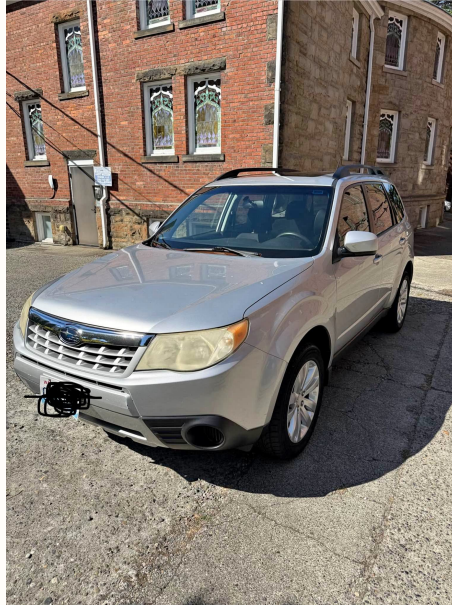
Front three-quarter. Silver 2.5X body looks straight; roof rails present. Headlight lenses are already yellowed — typical for this age, budget for restorations or replacements.

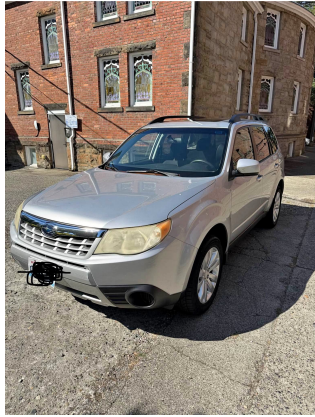
Front three-quarter. Silver 2.5X body looks straight; roof rails present. Headlight lenses are already yellowed — typical for this age, budget for restorations or replacements. Body looks straight from this angle; silver paint still reflective Both headlight lenses show yellowing/oxidation (common on 3rd-gen Foresters) Factory roof rails on; WA plate redacted in sample Listing shot only — no underbody, no engine bay, no interior

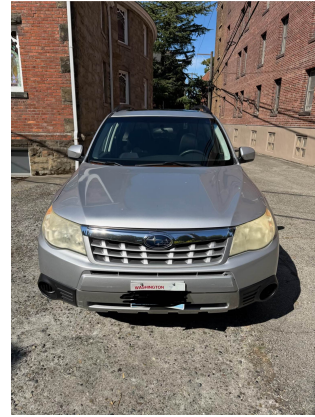
Front. Grille and emblem clean. Headlights cloudy/yellow on both sides. Lower fog housings look empty or dark. Plate is WA (redacted). Headlight clouding is obvious straight-on — ask seller about restorations already done Fog-light openings present; lenses look missing or blacked out in this shot Hood reflections show small white flecks — chips vs dust; check in person Harsh sun + alley photo — hides panel waves and rocker rust

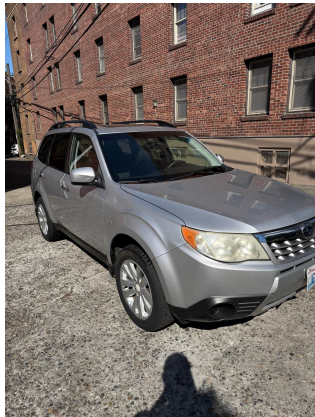
Driver-front three-quarter. Alloys and paint look tidy from distance. Passenger headlight haze still visible. Photographer's shadow in frame — typical Marketplace snap. Multi-spoke alloys look stock-ish; tread not readable from this distance No obvious door dings or bumper scrapes in this crop Still no shot of rockers, wheel wells, or undercarriage (rust country for Subarus) Bright daylight flattens paint defects — walk the car in shade

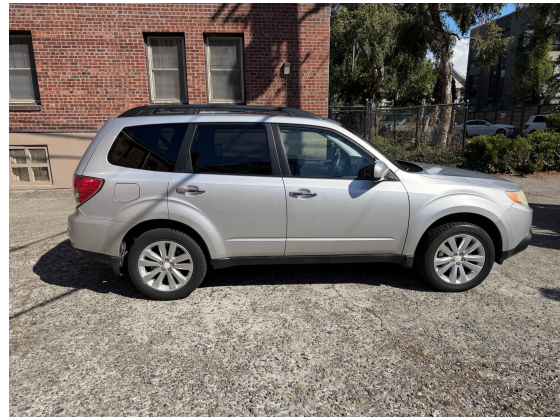
Driver side. Profile is clean; rear glass tinted. Black cladding and rocker trim look intact from here. Headlight tip still shows haze. Driver-side body line looks straight; cladding intact Rear windows darker than front — cosmetic, not a health signal No close-up of rocker rust, jack points, or wheel-arch bubbles Fuel door on rear right (far side) — not useful from this angle

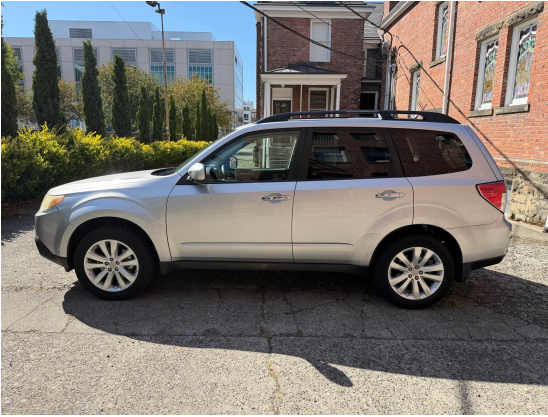
Passenger side. Same story as the driver side: tidy from 20 feet, yellowed front lamp, cracked lot under the car. Nothing here proves a clean underbody. Passenger-side panels look consistent with driver side Front passenger lamp haze again — budget for both sides together Lot surface is cracked/pebbled — irrelevant to the car, useful reminder these are street photos Still zero interior, engine, or lift shots in the ad

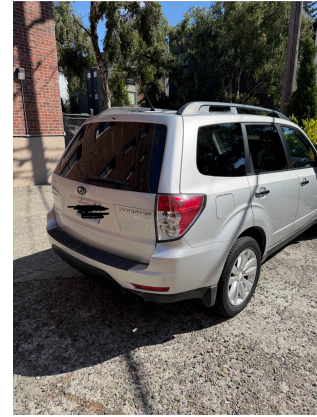
Rear three-quarter (passenger). FORESTER + PZEV badges, tinted hatch glass, WA plate. Paint still shiny; taillights look intact. Rear badges match a PZEV 2.5X Forester story Taillight assemblies look unbroken from this angle Hatch glass tinted; rear wiper present Useful for shape — not for head-gasket, CV boots, or frame rust

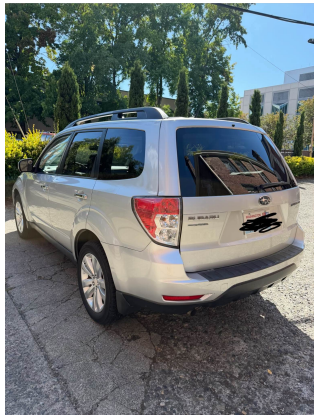
Rear three-quarter (driver). SUBARU / SYMMETRICAL AWD / PZEV badging clear. Black lower bumper trim shows light scuffs — loading wear, not fatal. AWD and PZEV badges visible; consistent with listing claim Minor scuffs on black rear bumper step area — typical cargo wear Rear tire tread looks decent from here (confirm with a penny/gauge) Panel gaps look even; still no underside photos

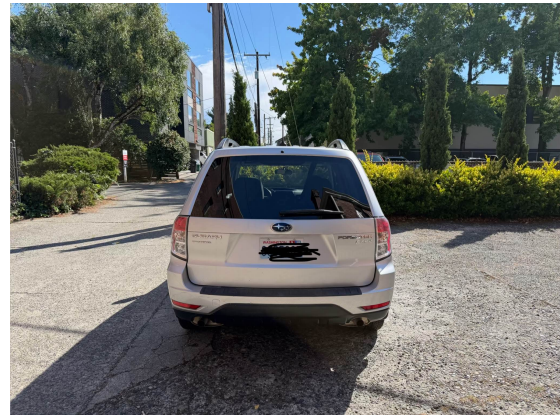
Straight rear. 2.5X + PZEV. Dual exhaust tips visible. Black hatch step pad present. Cleanest “what you’re buying” silhouette in the set — still exterior-only. 2.5X and PZEV badges confirm trim story from the ad Dual tips under the bumper — visual only; listen for exhaust leaks in person Rear bumper step pad and lower plastic look serviceable Eight exterior shots, zero cabin/odometer/engine — ask for those before you drive out
